Aerial Survey of Naches River, WA

Thermal Infrared and Color Videography

Report Date: December 14, 2004
Survey Date: August 14, 2004

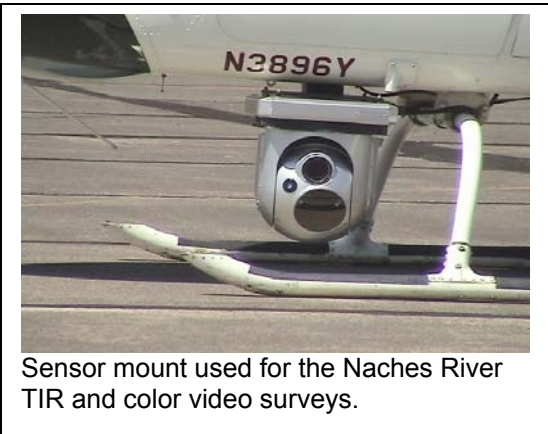
Instrumentation: Images were collected with TIR (8-12 μ) and visible-band cameras attached to a gyro-stabilized mount on the underside of a helicopter. The two sensors were aligned to present the same ground area, and the helicopter was flown longitudinally along the stream channel with the sensors looking straight down. Thermal infrared images were recorded directly from the sensor to an on-board computer in a format in which each pixel contained a measured radiance value. The individual images were referenced with time and position data provided by a global positioning system (GPS).

Flight Parameters: The survey of the Naches River was conducted from the confluence of the Little Naches River and the Bumping River, downstream to its confluence with the Yakima River. The river was surveyed from 2500 ft above ground level (AGL) in order to capture the many features of the river, including springs, tributaries, and segments of the river with multiple mainstream channels. The survey was conducted on August 14, 2004 between 1:55 PM and 3:15 PM.
